Arboriculture Assessment for 3707-3739 Dollarton Highway, North Vancouver BC

Diamond Head Consulting Ltd.
342 West 8th Ave
Vancouver BC
V5Y 3X2
604-733-4886

January 2008

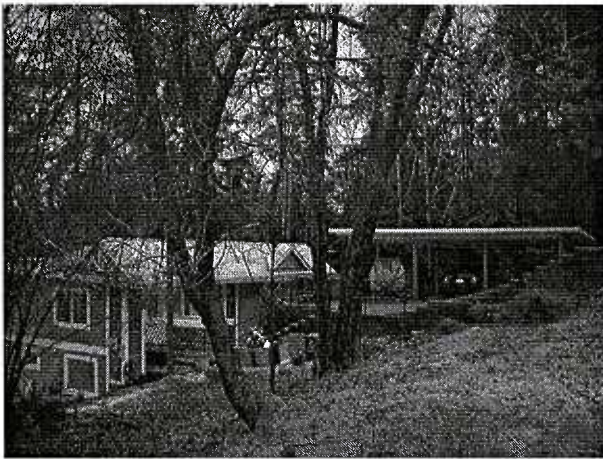
Looking west at the western boundary of trees, near the creek (the majority of which are located on the right of way). The house in the foreground will remain on the site.

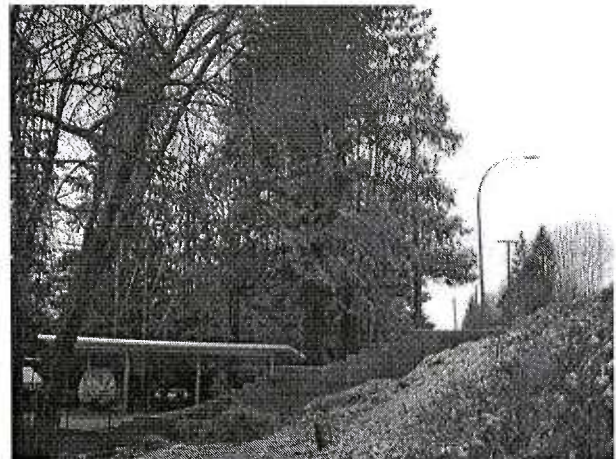
Looking at the northwest corner of the site.

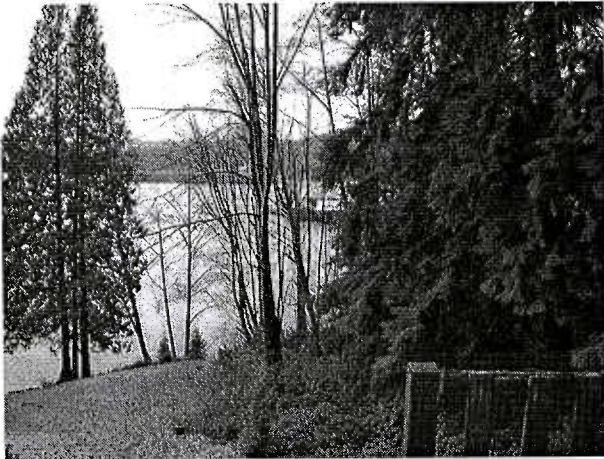
Looking to the south (in the western corner) at the larger cedars near the foreshore, with the creek at the right edge of the photo.

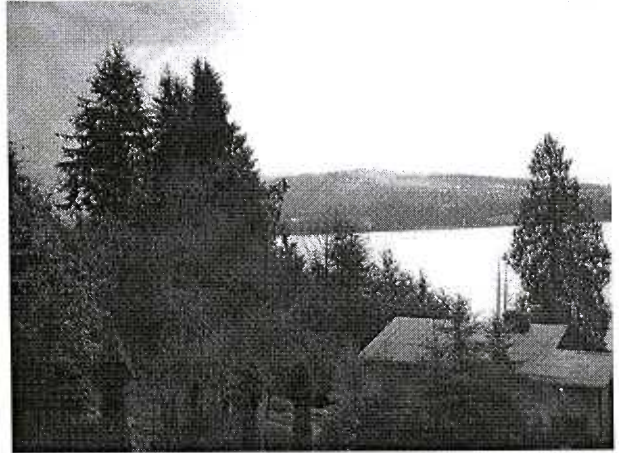
Looking east at the larger trees located in the southeast corner of 3739 and the adjoining property. Note that in the middle of the lots there are a number of small, young trees.

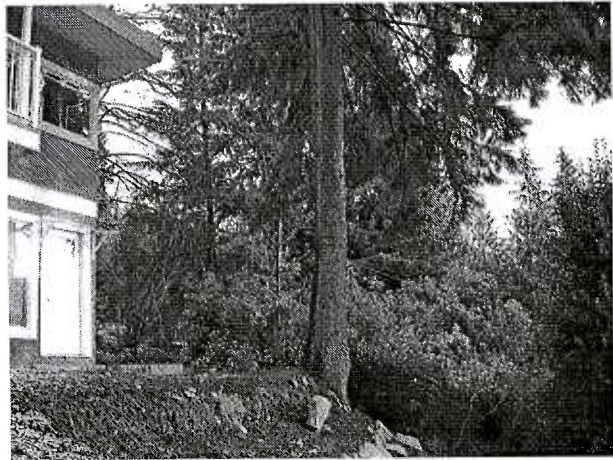
Looking at tree # 237. This tree has a codominant stem and boring dust at its base.

237	Hw	48,62	29	-	Codominant stem with moderate inclusion - boring dust at base - likely impacted by deck installation - Remove
236	Tilia	68	17	6	Good health, nice form
24	Mb	40,48	28	5	Codominant stem with minor inclusion

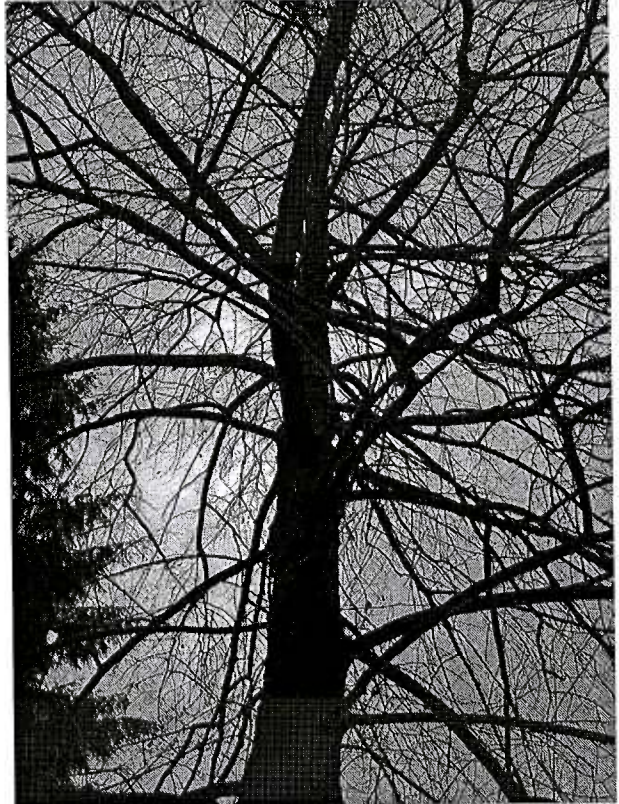
Tree # 236

Four trees of significance were found on the proposed development site. Tree #'s 236 a linden (*Tilia* spp.) and 923, 50 and 892 Western redcedars. The linden tree is significant due to its species size and form and the western redcedars due to their size. Retention areas will have to focus on the edges of the development where trees must be retained (by the creek and foreshore), or where there is enough room for healthy root development and where it is possible due to the proximity of adjacent trees to ensure a windfirm group.
