**Eelgrass Survey  
Seaward of 3707 Dollarton Highway, North Vancouver, February 2008**

Submitted February 2008

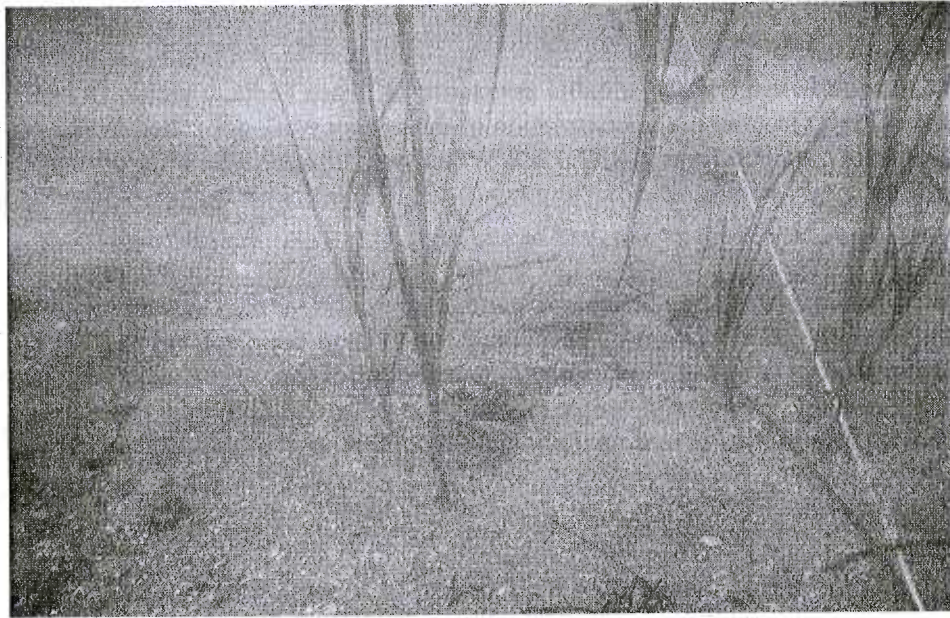
**Image 1) Eelgrass community -1.5 m relative to zero chart datum**
