**A Subtidal Marine Plant Community Survey  
Seaward of 3707 Dollarton Highway, North Vancouver, April 2015**

On Wednesday April 15<sup>th</sup> 2015 Seacology completed a subtidal marine plant community survey in front of a proposed subdivision development at 3707 Dollarton Highway in the District of North Vancouver. The area covered by the eelgrass bed has been reduced by nine percent since the 2008 survey. Macro algae subtidally is limited by substrate which is ninety percent silt and sand and ten percent pebble (modified Wentworth scale) on the eastern half of the water lease. Pebble and cobble account for twenty percent of the mostly silt and sand substrate on the western half of the water lease. Macro algae was observed on the western half of the water lease to a depth of -6.0 m depth relative to chart datum.

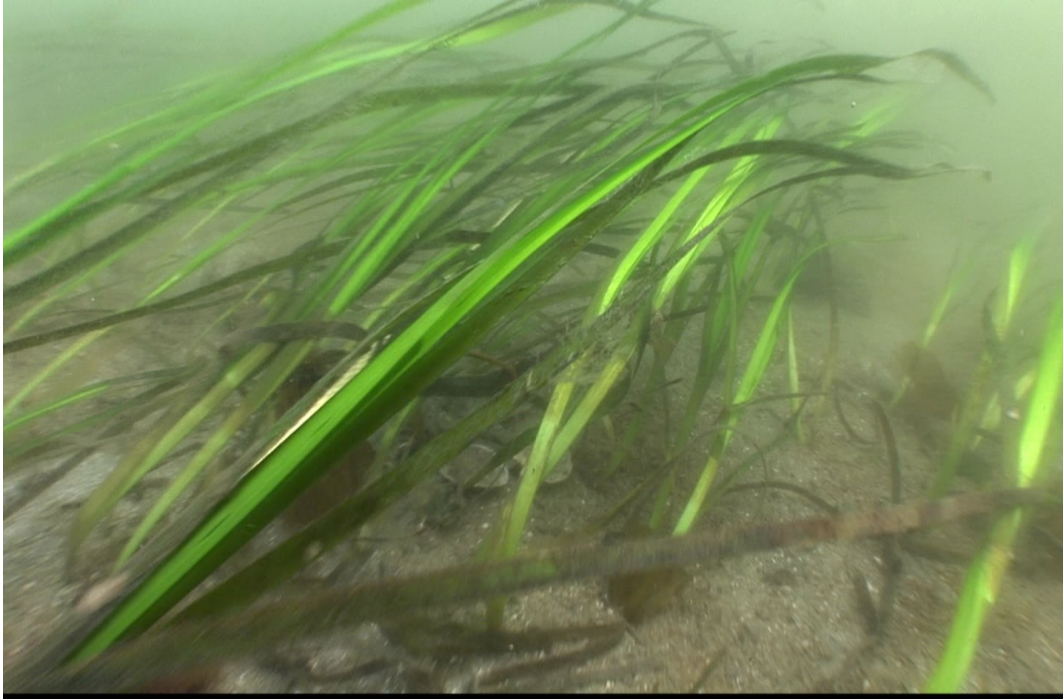
*Illustration 1: Eelgrass, Zostera Japonica near -0.5 m depth relative to chart datum*

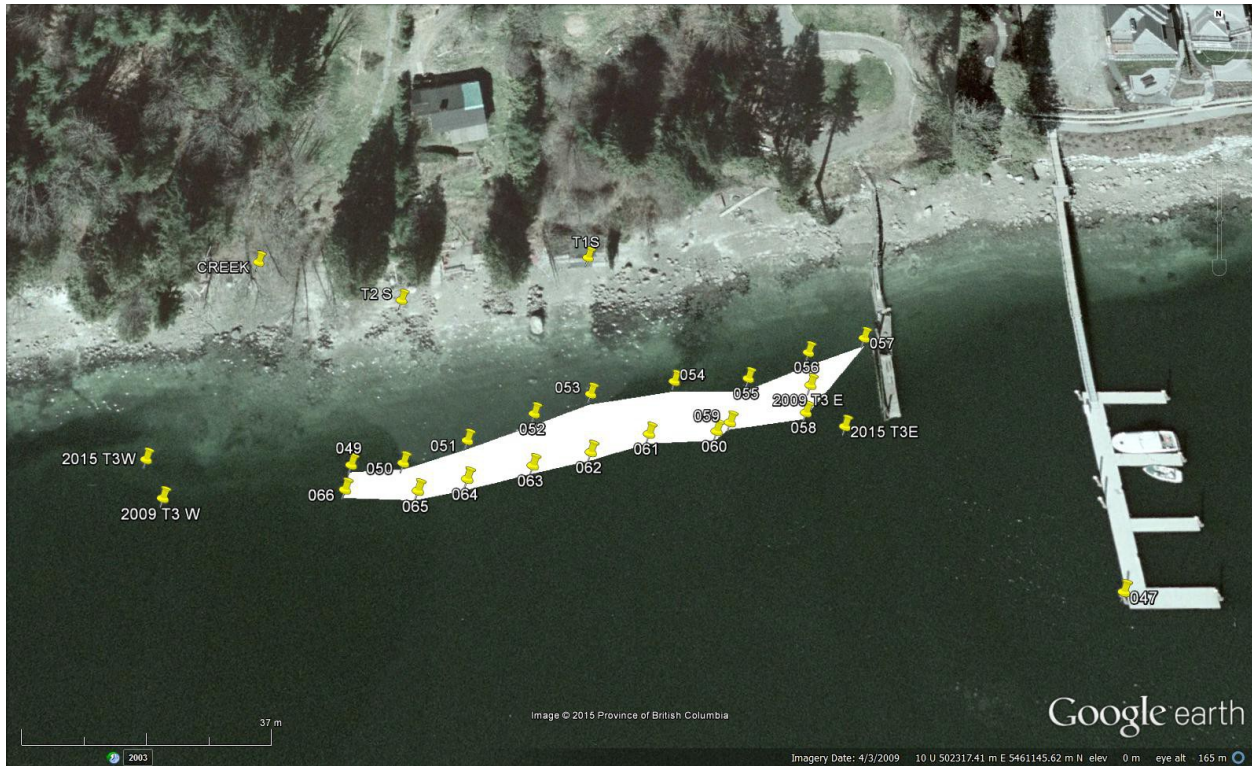
Eelgrass was observed at depths between 0.1 and -1.5 meters relative to chart datum. The distribution of eelgrass is depicted in the Google earth image in Illustration 2 below.

Illustration 2: GPS way points plotted onto an aerial image of the site. Lines connecting way points to create the polygon are interpolations.

Eelgrass losses since the 2008 survey at the site have occurred at the western end of the eelgrass bed and possibly at the eastern end of the eelgrass bed in the adjacent foreshore lease, see illustration 2 above. There is a small creek that enters the foreshore lease at the western end of the eelgrass bed and debris from previous extreme high runoff events since 2008 may have contributed to losses here. A pile secured floating dock structure, not present during the 2008 eelgrass survey, may have contributed to eelgrass bed area reductions at the eastern side of the area surveyed.

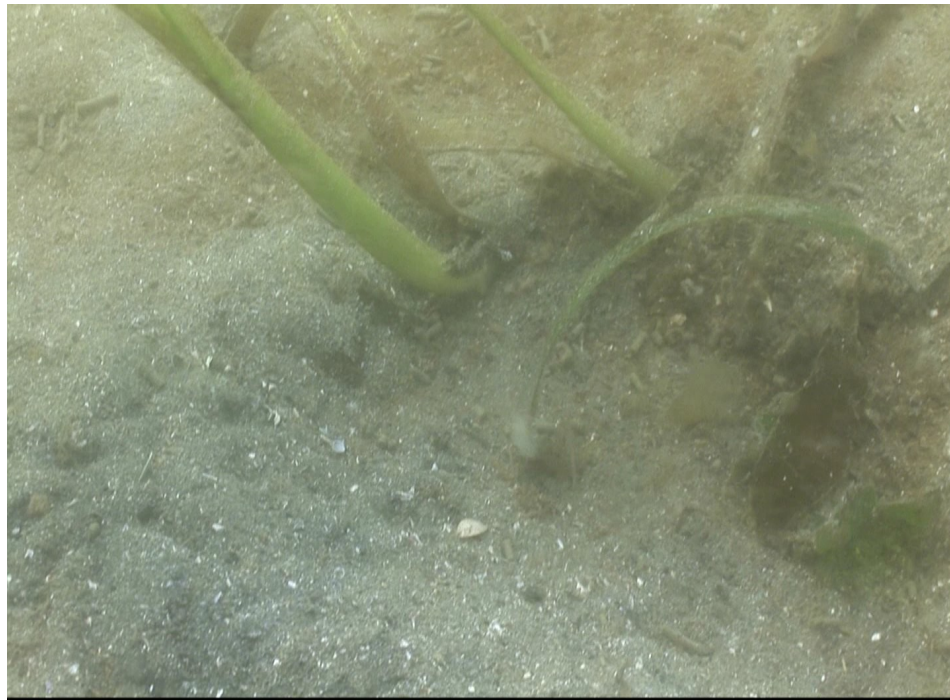
*Illustration 4: Eelgrass shoot with closeup of sheath and first node exposed. Excavation appeared to be the result of dungeness crab.*

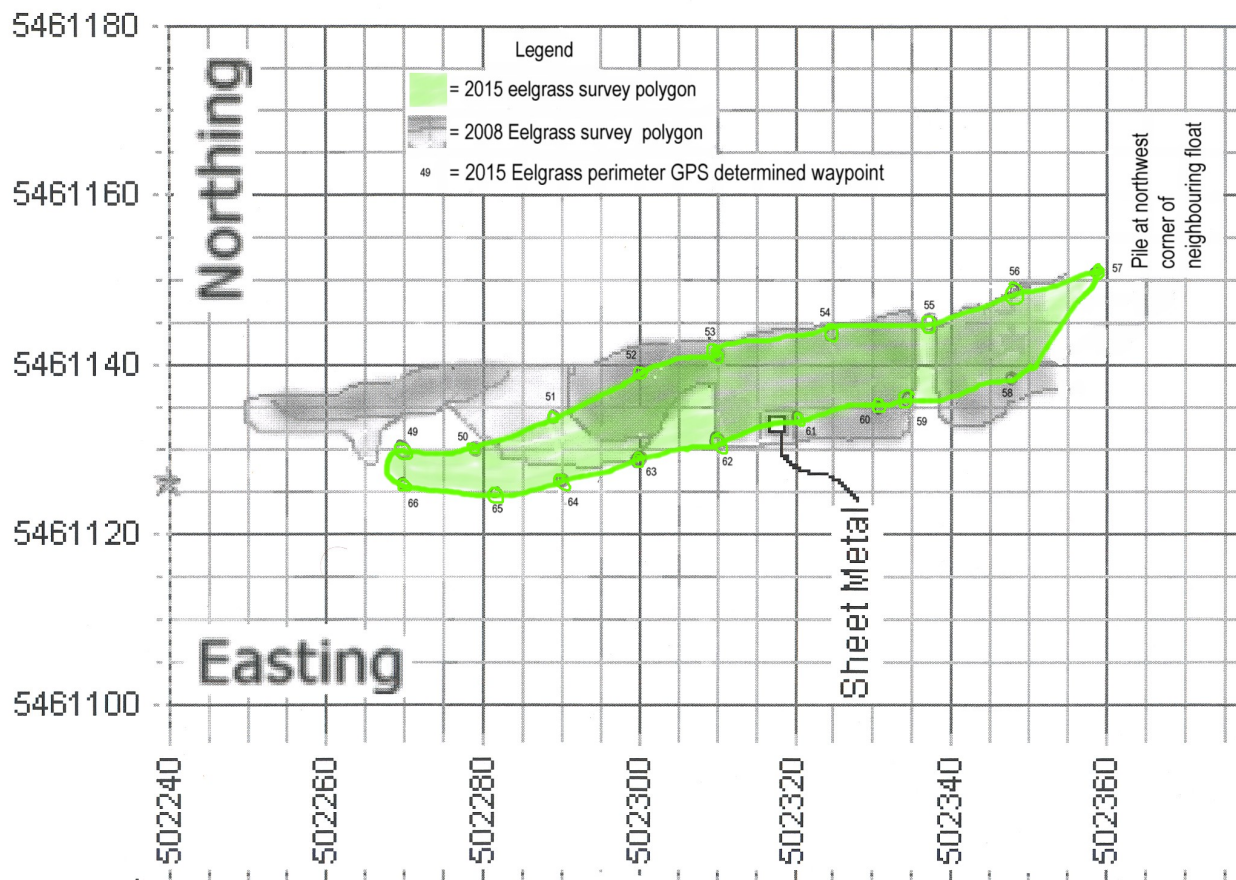
*Illustration 5: 2015 Eelgrass survey with GPS way points polygon shaded in green with grey shaded 2008 eelgrass surveyed polygon plotted onto a UTM Grid with way points obtained using WGS84 datum.*

A sheet metal structure was partially exposed near the middle of the eelgrass bed. It may be the transom of an aluminum car-topper boat or one side of a large metal tote, see illustration 5 above. Removal of this debris could increase the area colonized by eelgrass by its footprint approximately 1.5 m<sup>2</sup>.
